LARGO & NEWBURN PARISH CHURCH

Tod & Taylor Architects

CONDITION SURVEY REPORT OCTOBER 2014

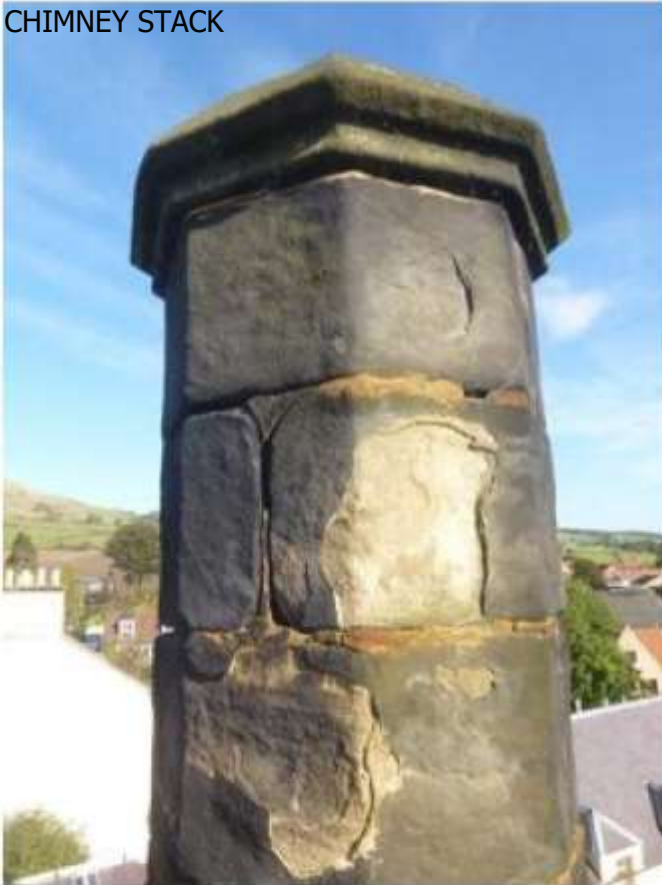
| | Element | Description | Condition | Action | Priority | Cost |
|---|---|---|--|---|---|---|
| 6.1.19 | Chimney | Stone built chimney on East wallhead | Very open joints in masonry | Access, dismantle and rebuild with stones dowelled in position | B | £ 2,500 |

CHIMNEY STACK

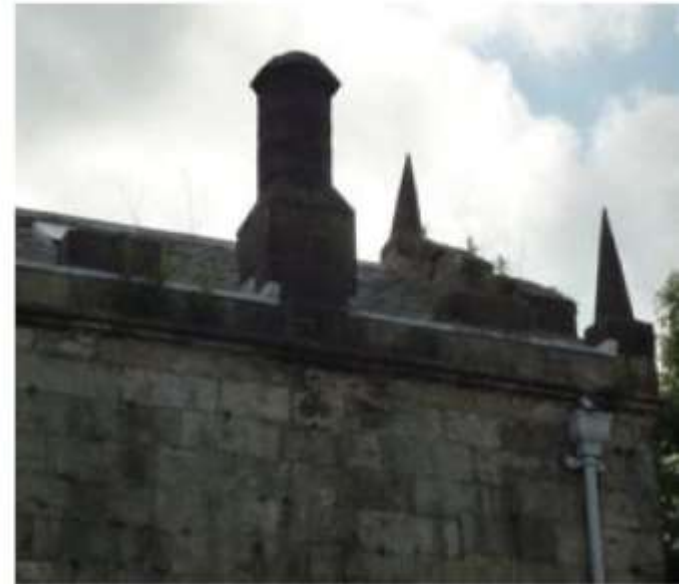
| | Element | Description | Condition | Action | Priority | Cost |
|---|---|---|--|---|---|---|
| 6.1.18 | East gutter | Lead lined gutter has sunk from the bay beside the outlet to the chimney and the bay North of the chimney | Gutter sole rotted. Water backs up due to outlet being choked, and sole sunken | Access, strip out lead, repair rotted timber sole and remake gutter | B | £ 10,000 |

LEAD LINED GUTTER BEYOND CHIMNEY
HAS SUNKEN SOLE

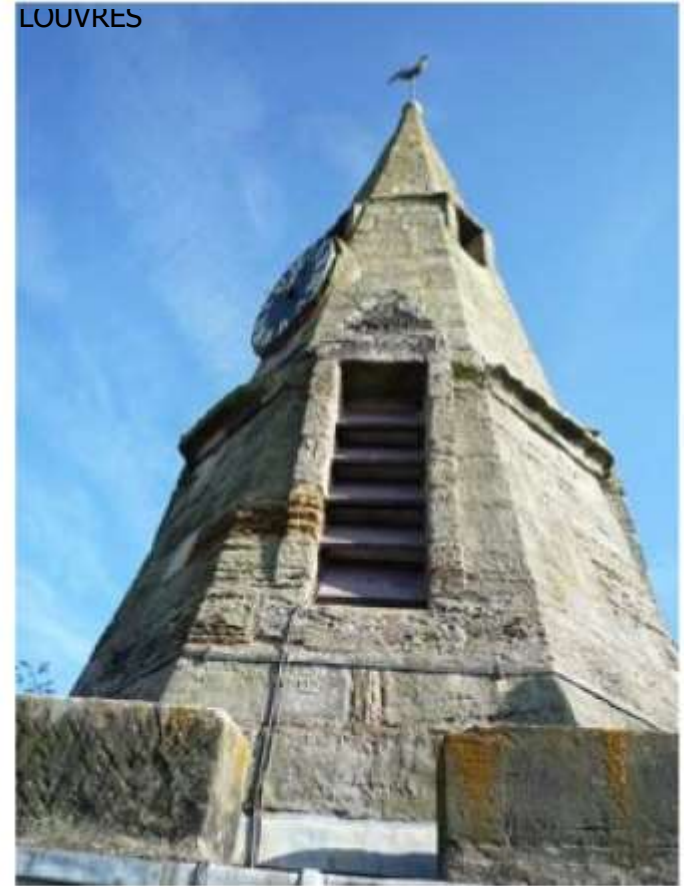
| | <i>Element</i> | <i>Description</i> | <i>Condition</i> | <i>Action</i> | <i>Priority</i> | <i>Cost</i> |
|---|--|--|--|---|---|---|
| 6.1.6 | | Openings with timber louvres. | Paintwork failing | Prepare and paint louvres. | B | £ 1,000 |

LOUVRES

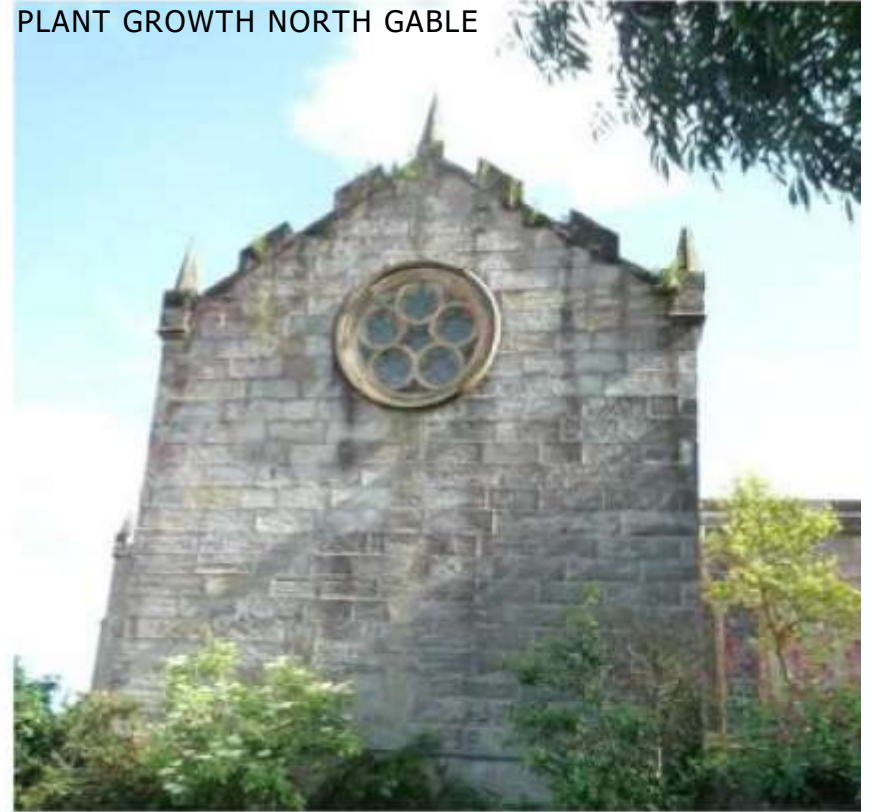
| | <i>Element</i> | <i>Description</i> | <i>Condition</i> | <i>Action</i> | <i>Priority</i> | <i>Cost</i> |
|---|---|---|---|--|---|---|
| 6.1.16 | Top of North Gable | Masonry battlemented | Plants growing including established cotoneaster at foot of west skew | Arrange access and remove all plant growth, poison roots and fill holes with suitable mortar. Point up open joints | B | £ 2,800 |

PLANT GROWTH NORTH GABLE

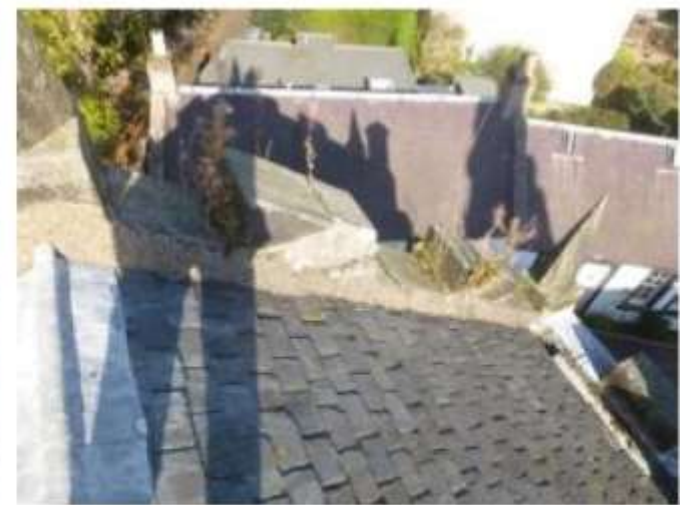
COTONEASTER
