LARGO & NEWBURN PARISH CHURCH

Tod & Taylor Architects

CONDITION SURVEY REPORT OCTOBER 2014

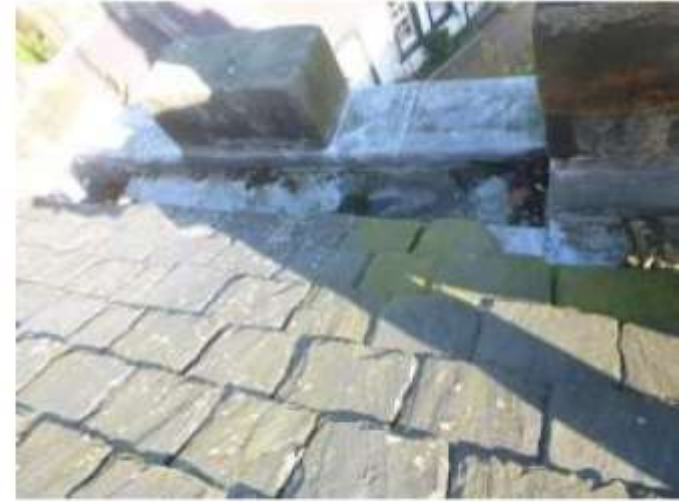
| | Element | Description | Condition | Action | Priority | Cost |
|---|---|---|--|---|---|---|
| 6.1.18 | East gutter | Lead lined gutter has sunk from the bay beside the outlet to the chimney and the bay North of the chimney | Gutter sole rotted. Water backs up due to outlet being choked, and sole sunken | Access, strip out lead, repair rotted timber sole and remake gutter | B | £ 10,000 |

LEAD LINED GUTTER BEYOND CHIMNEY
HAS SUNKEN SOLE

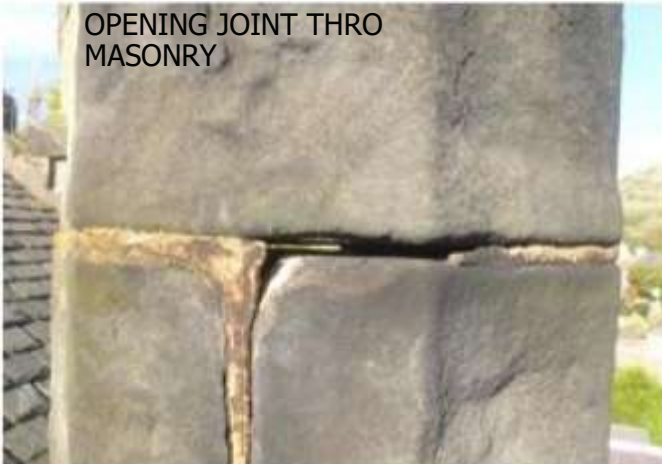
OPENING JOINT THRO
MASONRY

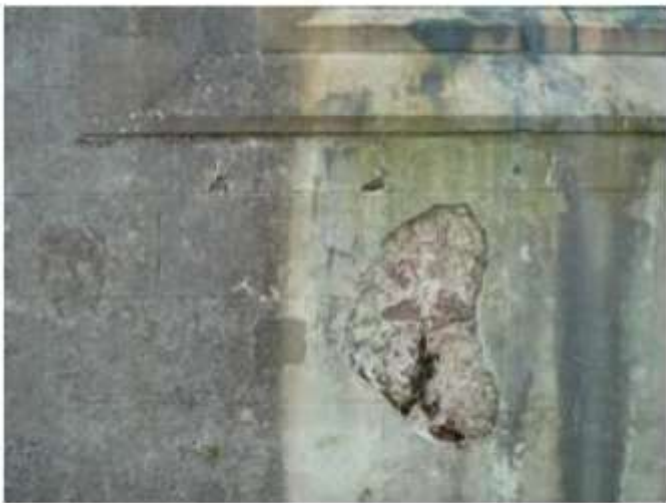
HARLING REMOVED FROM EAST GABLE TO REVEAL STONEMWORK

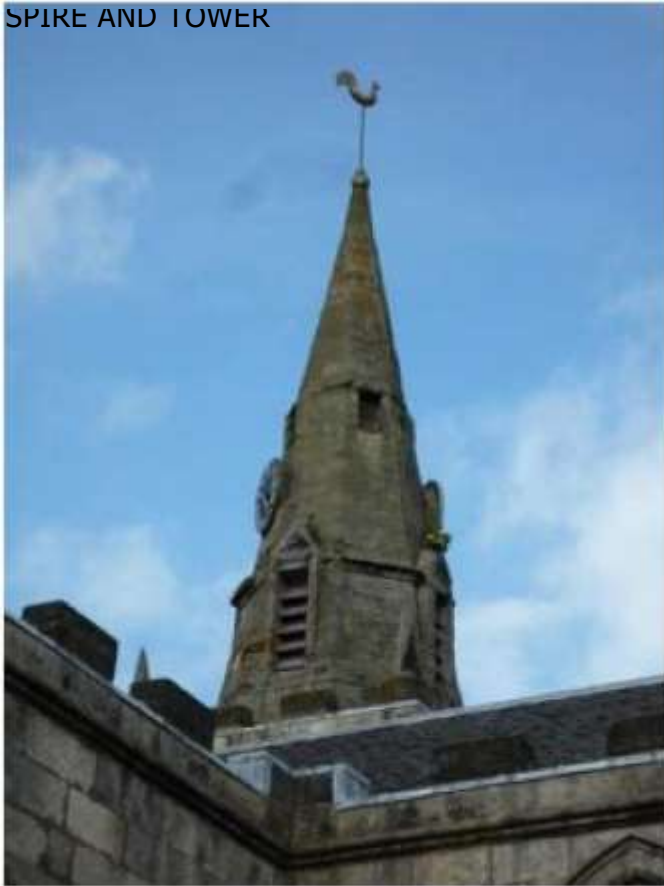
SPIRE AND TOWER

| | <i>Element</i> | <i>Description</i> | <i>Condition</i> | <i>Action</i> | <i>Priority</i> | <i>Cost</i> |
|---|--|--|--|---|---|---|
| 6.1.4 | Spire | Stone | Some hard pointing failing. | Provide access. Repoint at open joints using a good lime mortar | B | £ 13,000 |

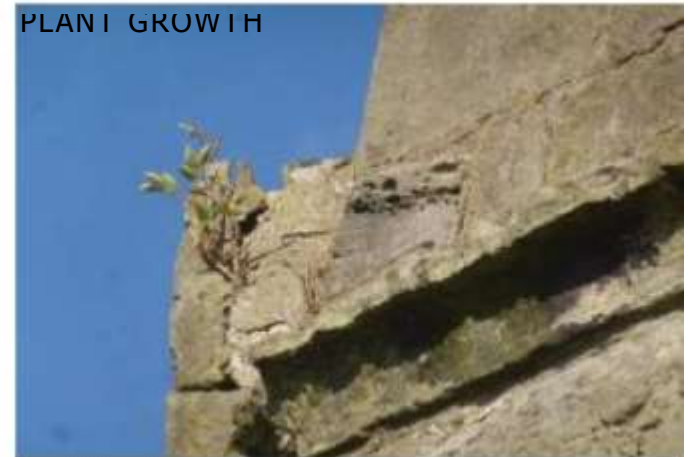
PLANT GROWTH
